Type III Micro Surfacing To Extend the Life of Old Concrete Pavement-I-70 MM 10 +/-

Interim Report

Experimental Feature X(06)02-New Products

Utah Department of Transportation
Research Division

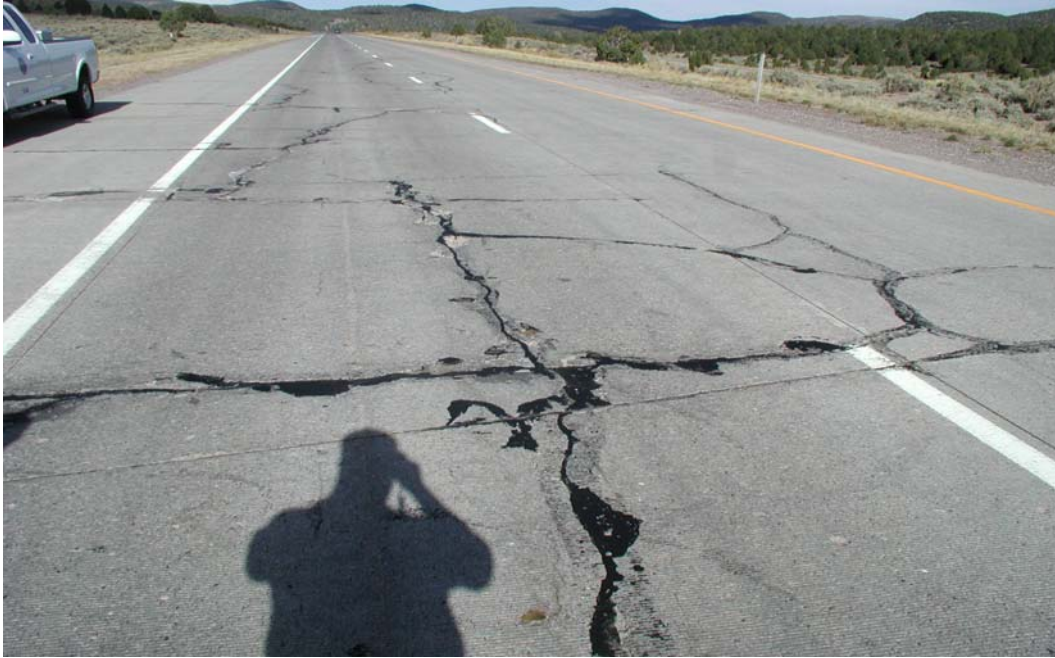
Before

The Utah Department of Transportation, Region Four Operations diamond ground the major portions of I-70 concrete to improve the skid and ride. The eastbound outside lane of I-70 at the east abutment of the Shingle Creek Structure, MM 10 +/- exhibited severe transverse cracking and degradation in general.

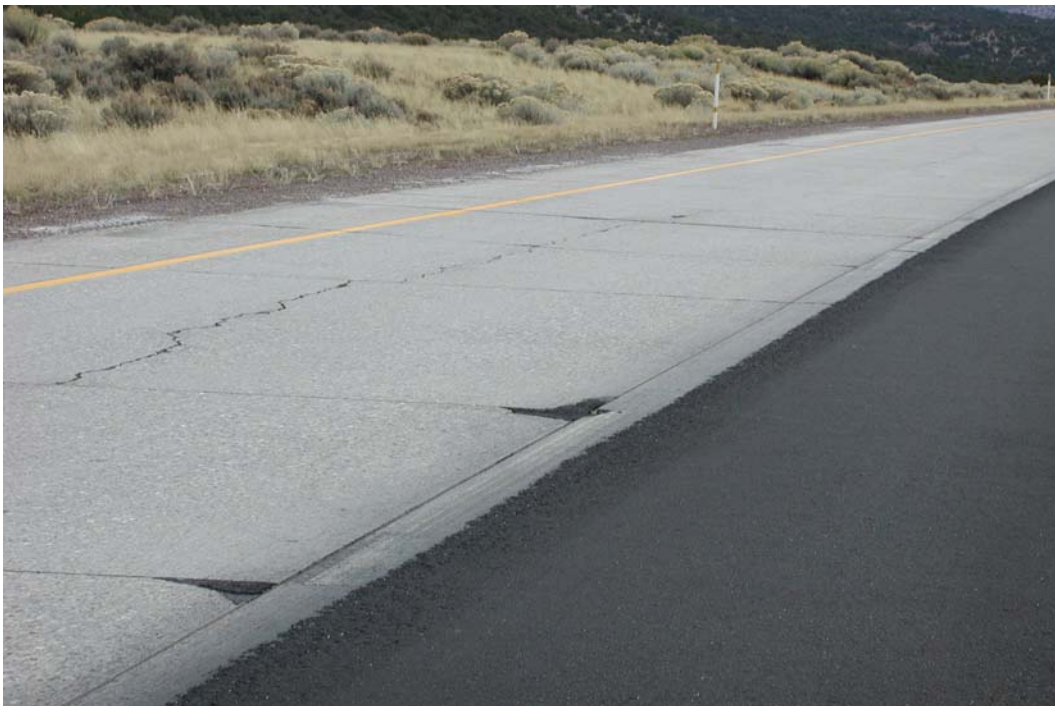
After

Product was visually evaluated in the fall of 2005 and the micro surfacing showed no evidence of failing but where the concrete joints were the material had cracked but has no affect on how the overlay is performing.

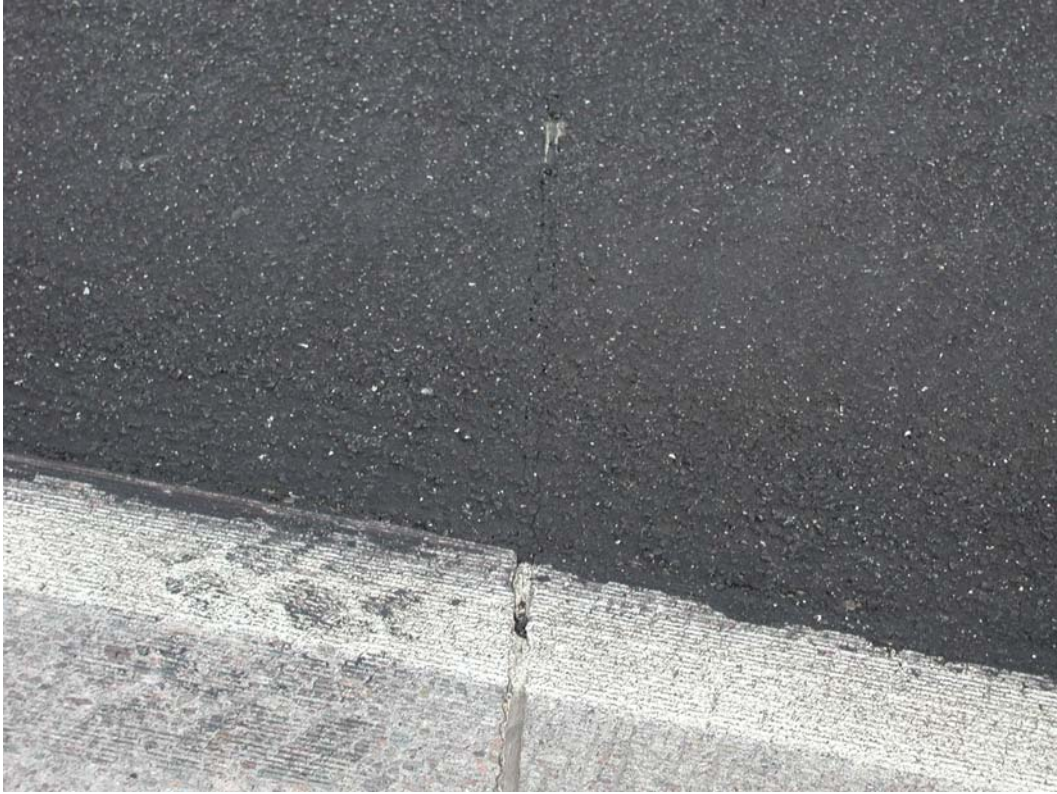
Problem Solved Using Crack Sealant

A visual inspection was made June 1, 2006 by Barry Sharp, and pictures were taken that indicate no more wear or change that is seen in the above picture. The product is working well and the indications are that it will provide an extension of life for this particular piece of roadway. The two annual evaluations will be forthcoming, one this year and then at least two next year and then recommendations will be made at that time. One of the key benefits of this process is that traffic was allowed within four hours of the application. The surface was an even textured while the harsh aggregate furnished very good skid numbers.
